QA-154
202 South Liberty Street
Centreville
private

INVENTORY FORM FOR STATE HISTORIC SITES SURVEY

202 South Liberty Street

QA-154
John Sause Residence

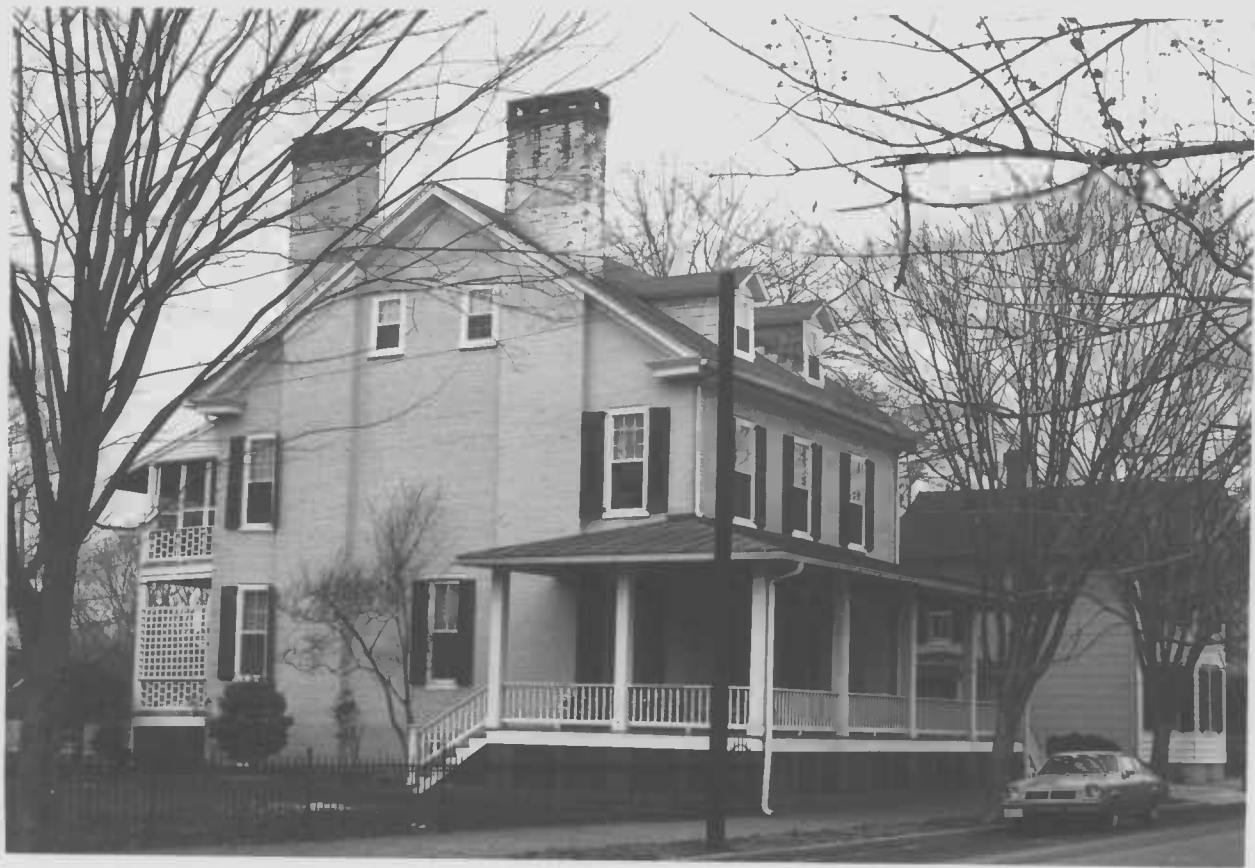
QA-154 Sause Residence
 Centreville, Maryland
 Orlando Ridout V, 1978
 View from Southeast

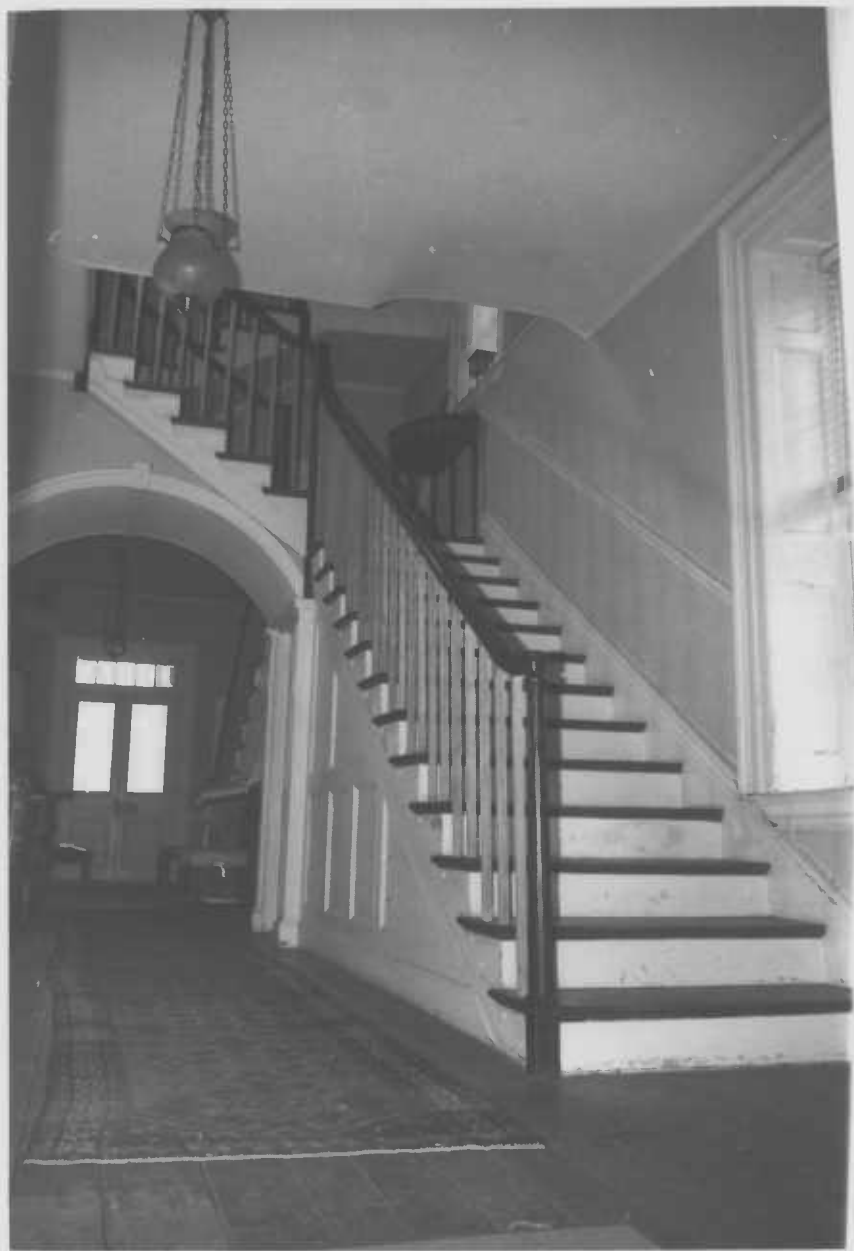
QA-154 Sause Residence
Centreville, Maryland
Orlando Ridout V, May 1978
Interior stair

The interior plan consists of a side stair passage with two nearly equal size rooms on the south. It differs from most side passage houses, in that the stair ascends from both ends of the passage to a landing in the center, thence in a single run to the second story. Beneath the second flight is a wide arch connecting both ends of the passage. The open string stair with delicate balustrade, scrolled step ends and paneled

spandrel are all original, as are the window jamb panels, chair rail and door trim.
